## Smoke and Dye Water Observation Summary

### Western Run Pilot Project - Baltimore Maryland

## INSPECTION REPORT

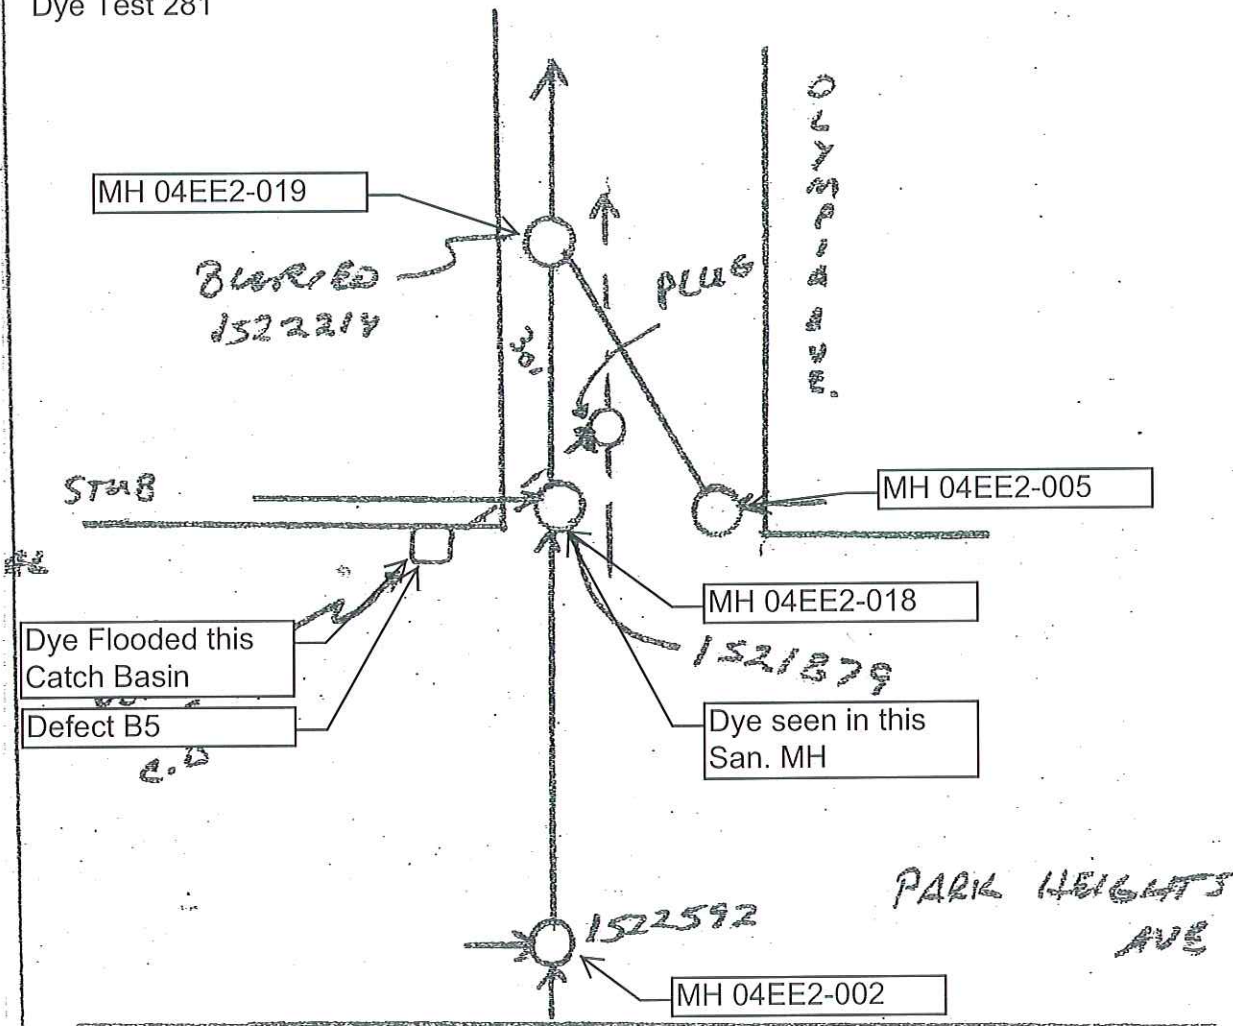
Sketch (NTS)  
Dye Test 281

Additional Comments: LEAK WERE ALL AROUND IN M.H 1521879.

ALSO ALL THE FIRST JOINTS UP ALL THREE  
PIPES OUT OF M.H 1521879 WERE LEAKING HEAVY  
& 2 TO 3 JOINTS FARTHER WERE LEAKING LIGHTLY.

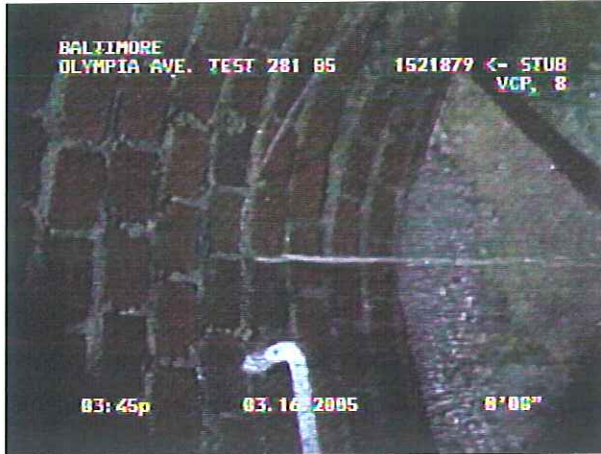
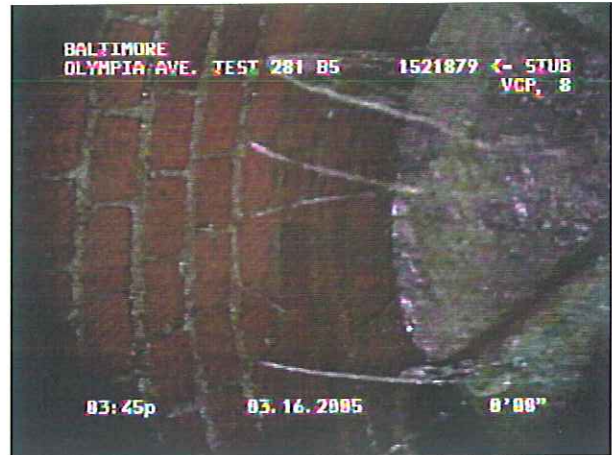
IMAGE: 8a, TAPE #: JAM 1, 00:08:02  
0FT, LEAKS ALL AROUND M.H. 1521879

IMAGE: 8b, TAPE #: JAM 1, 00:08:02  
0FT, LEAKS ALL AROUND M.H. 1521879

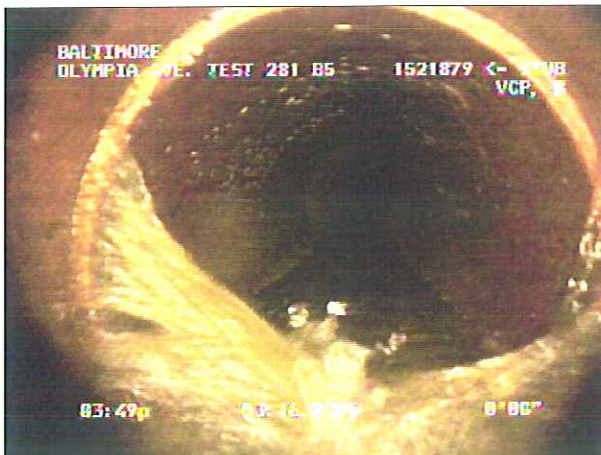
IMAGE: 9a, TAPE #: JAM 1, 00:10:19  
4FT, Infiltration Gushing at joint at 02 o'clock TO 10 o'clock

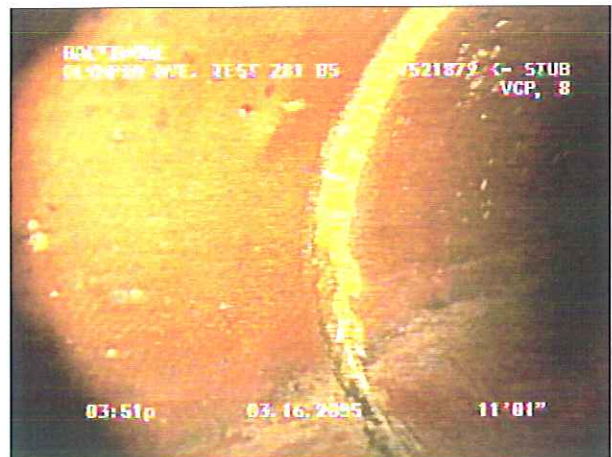
IMAGE: 10a, TAPE #: JAM 1, 00:11:47  
11.07FT, Infiltration Running at joint at 08 o'clock

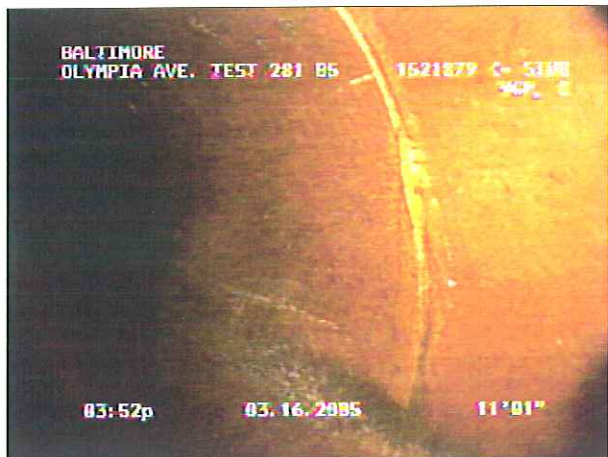
IMAGE: 11a, TAPE #: JAM 1, 00:11:47  
11.07FT, Infiltration Running at joint at 04 o'clock

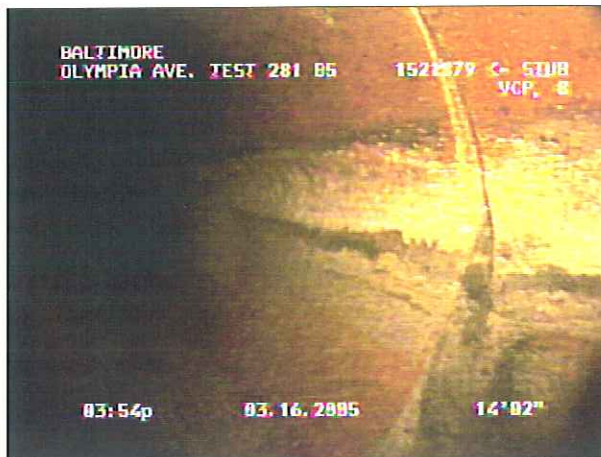
IMAGE: 12a, TAPE #: JAM 1, 00:12:31  
14.19FT, Infiltration Running at joint at 05 o'clock

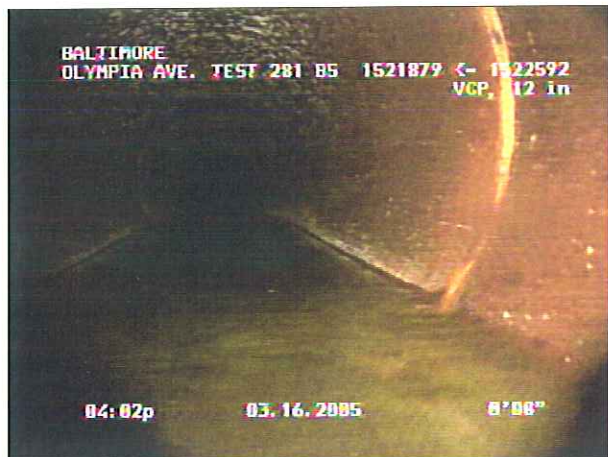
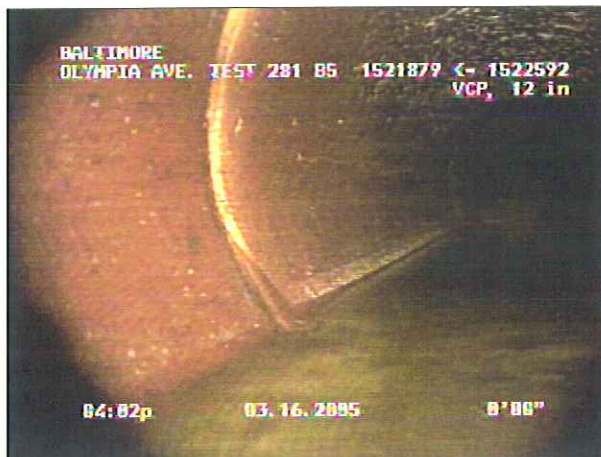
IMAGE: 15a, TAPE #: JAM 1, 00:15:16  
4FT, Infiltration Running at joint at 04 o'clock to 8 o'clock

IMAGE: 15b, TAPE #: JAM 1, 00:15:16  
4FT, Infiltration Running at joint at 04 o'clock to 8 o'clock

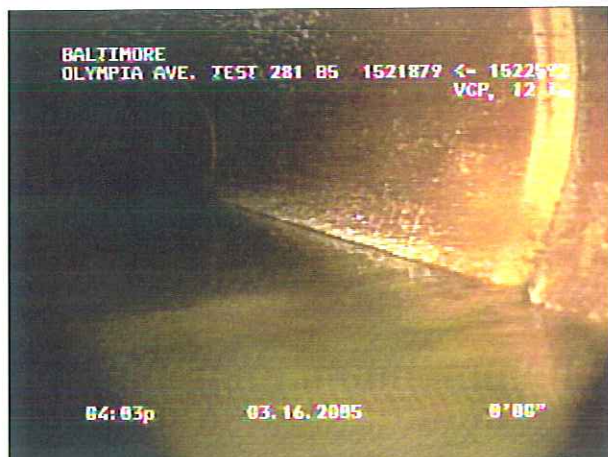
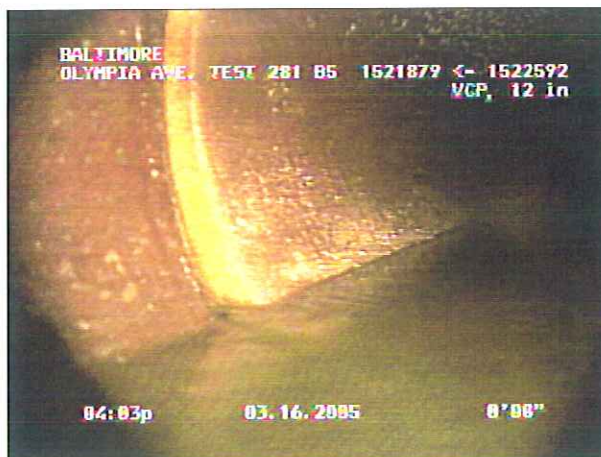
IMAGE: 16a, TAPE #: JAM 1, 00:15:39  
7FT, Infiltration Running at joint at 04 o'clock to 8 o'clock

IMAGE: 16b, TAPE #: JAM 1, 00:15:39  
7FT, Infiltration Running at joint at 04 o'clock to 8 o'clock

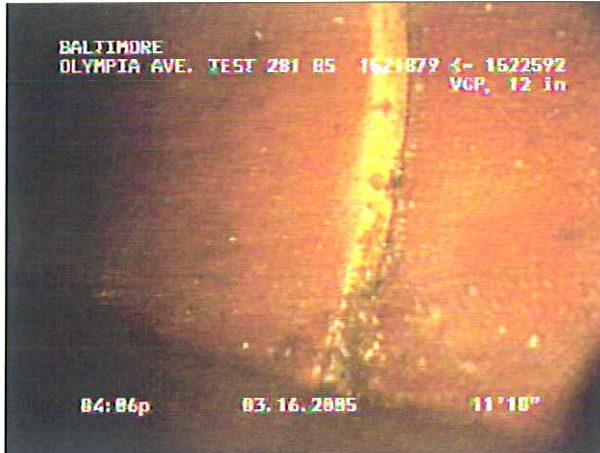
IMAGE: 17a, TAPE #: JAM 1, 00:16:18  
11.87FT, Infiltration Dripping at joint at 04 o'clock

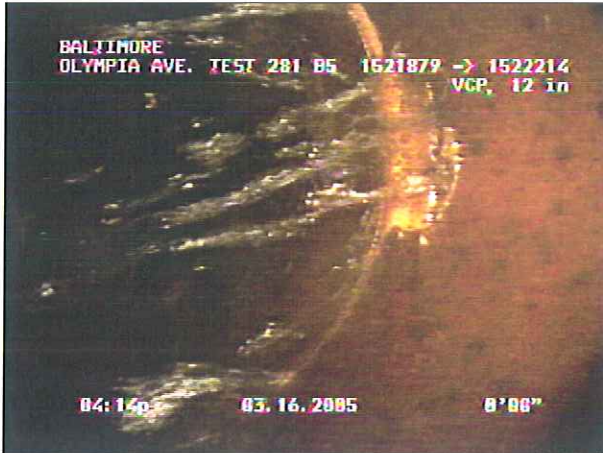
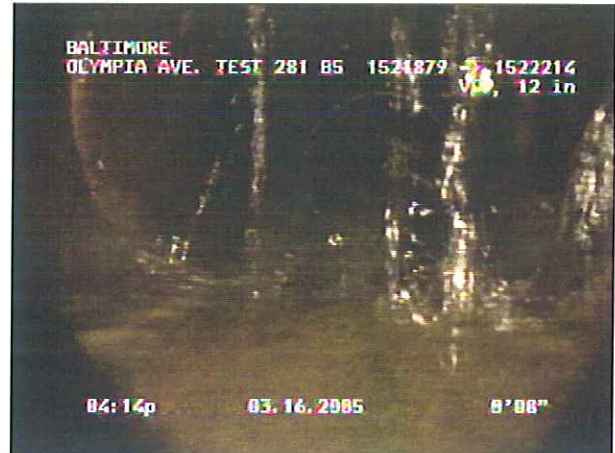
IMAGE: 20a, TAPE #: JAM 1, 00:19:49  
4FT, Infiltration Gushing at joint at 12 o'clock TO 12 O'CLOCK

IMAGE: 20b, TAPE #: JAM 1, 00:19:49  
4FT, Infiltration Gushing at joint at 12 o'clock TO 12 O'CLOCK

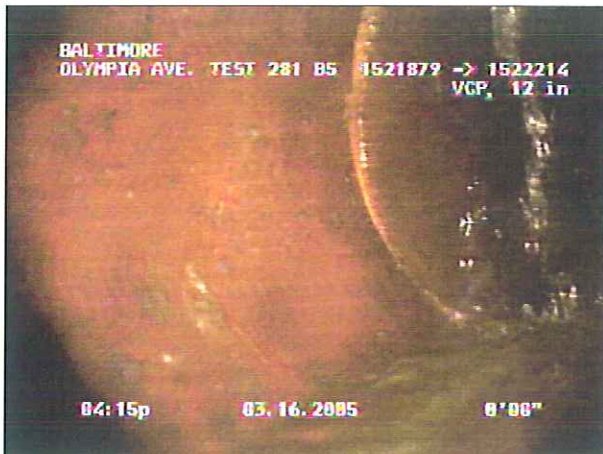
IMAGE: 21a, TAPE #: JAM 1, 00:20:14  
4FT, Circumferential Crack at joint from 06 to 10 o'clock

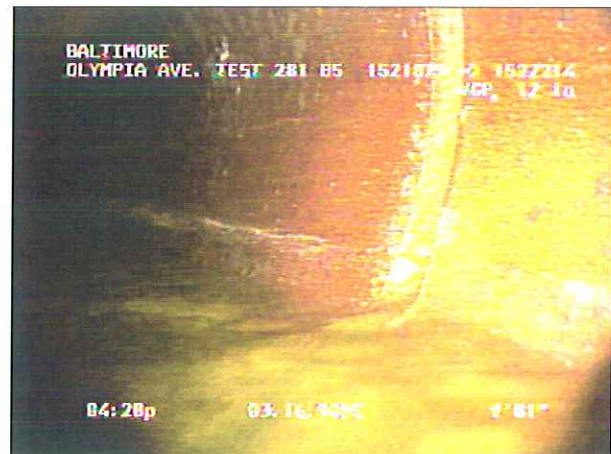
IMAGE: 22a, TAPE #: JAM 1, 00:22:48  
9.06FT, Infiltration Running at joint at 04 o'clock
